BEAR ROCK NO.1 DAM

NDI I.D. NO: PA-00439

PHASE I INSPECTION REPORT
NATIONAL DAM INSPECTION PROGRAM

NAME OF DAM: Bear Rock No. 1 Dam
STATE LOCATED: Pennsylvania
COUNTY LOCATED: Cambria
STREAM: Bear Rock Run
SIZE CLASSIFICATION: Small
HAZARD CLASSIFICATION: High
OWNER: Highland Sewer and Water Authority
DATE OF INSPECTION: November 13 and December 28, 1979

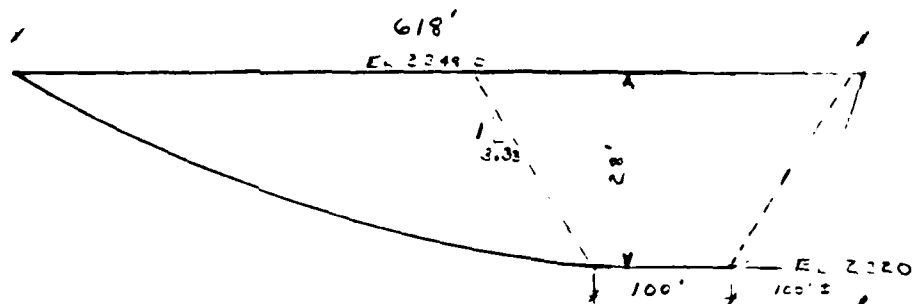
ASSUMED BREACH
BEAR ROCK * 1 DAM

ASSUME TIME FOR BREACH, 0.5 HOURS
FROM DER FINE DRAWINGS, THE FOLLOWING DAM
PROFILE AND BREACH ARE ASSUMED

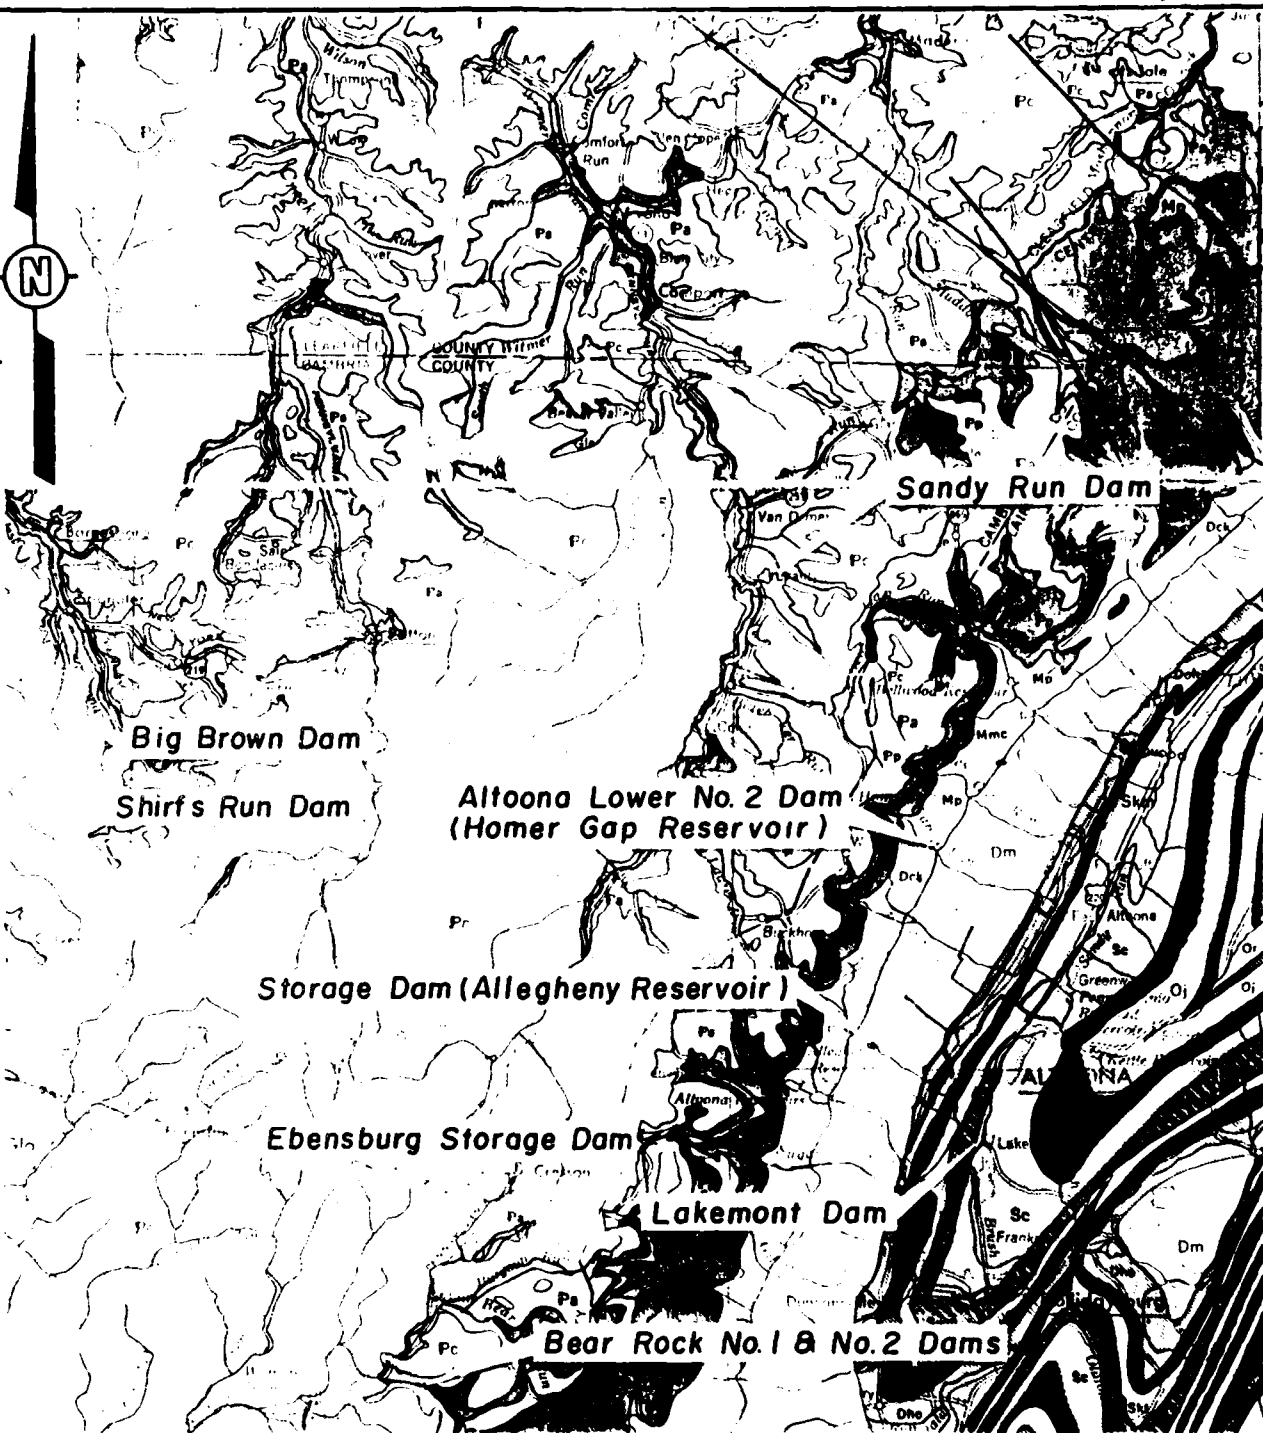
There is no minable coal beneath the dams and reservoirs. The strip mines on the slopes west and northeast of the reservoirs are probably the Lower Kittanning coal beds. The slopes above the reservoirs are relatively gentle, in general greater than 5 to 1, and probably consist predominantly of sandstone. Therefore, there should be no danger of large slides.
